Environment Agency Wales

ENGINEERING AUDIT

Sidewall Lining

Name of site: Trecatti Landfill Site Operator/Permit holder: Biffa Waste Services Ltd Permit ref no: RP3733PC

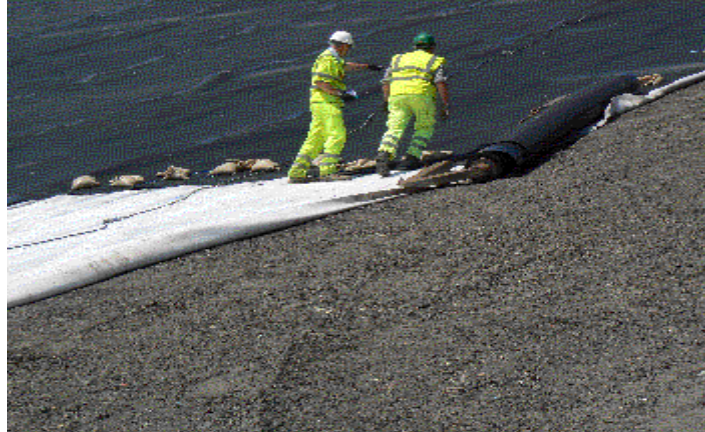
At the time of inspection formation levels had been established beneath most of the proposed works. The groundwater drainage blanket had been placed over the prepared formation and the liner support layer was progressing eastwards across the batter in discreet lifts. Geogrids were seen at the base of the support layer and above the first lift. A protective fabric was seen beneath the leading edge of the geomembrane panels that had been laid over the support layer.

The sidewall geomembrane panels had been tied-in to previous phases of works along the western edge (by fusion welding) and along the toe (by extrusion welding). During the visit one welding crew were on site working on the extrusion tie-in.

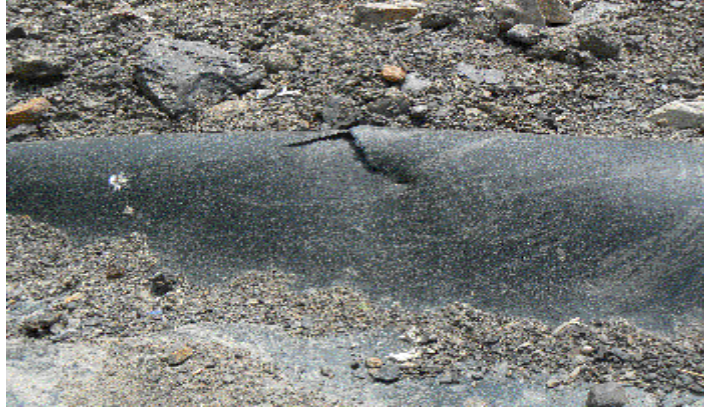
5. Defects – The walkover survey revealed the presence of several defects in the lining system. Whilst several of these lay outside the area of this phase of works we would expect to see them marked up and repaired. The records of these repairs should be included in the CQA Validation report.

5. Defects – Identify, mark, repair and record all defects within the current phase of works and the adjacent areas of the exposed liner.
6. Air pressure Tests – Mobilise air testing equipment to site as a matter of urgency and test all seams in accordance with the CQA Plan.

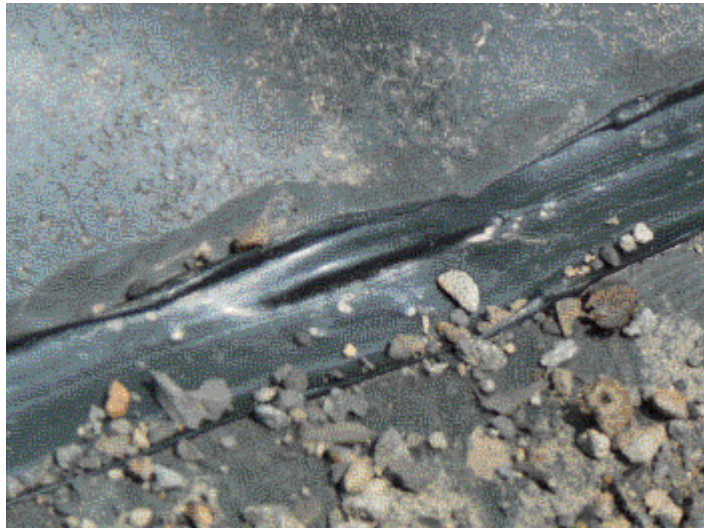
6. Air Pressure Tests – The lack of air testing equipment on site has resulted in the non-destructive testing of seams falling way behind the lining process. The CQA Engineer accepted that this was not good practice and that the failure of any of these seams could result in complex remedial works.
7. Extrusion Welding – Parts of the tie in extrusion weld are neatly and effectively welded, where as parts of the weld are ragged and show clear evidence of fish mouths between adjacent sheets. The validation of the seams by vacuum box methods is critical along the seam and the CQA Engineer's notes of this will be examined carefully during EAW assessment of the Validation Report.

7. Extrusion Welding – Carefully and meticulously carry out Vacuum Box testing along the extrusion tie in weld and supplement the weld test record sheet with photographs and/or notes made at each Vacuum Box increment.

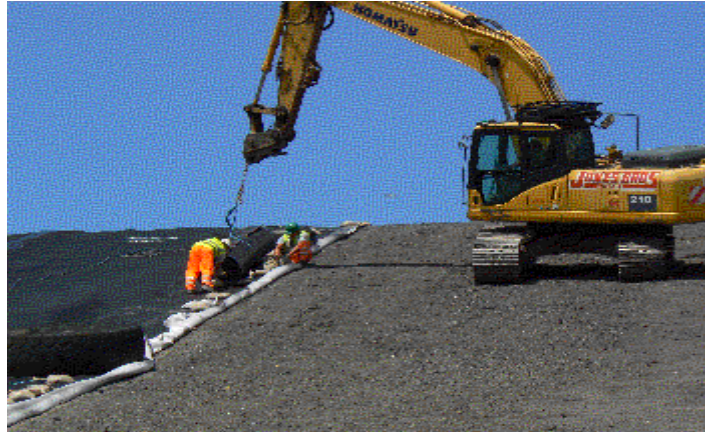
8. Health and Safety – During the site inspection the leading edge of the geomembrane was temporarily surcharged with an unused roll of geomembrane. The roll was secured on the edge of the membrane using a large tyre which proved inadequate to fix it into position. The roll moved down slope with the tyre some 15m before coming to rest on a wrinkle in the membrane.
At the time, staff from the contractor, consultant, Biffa and EAW were all inspecting works beneath the roll. It is clearly inappropriate to secure the leading edge on a steep slope

with a roll of membrane. This must be recorded as a near miss and should be investigated appropriately.

Furthermore, the grinding wheel used to prepare extrusion weld seams was seen to have the earth wire broken. A lightweight generator placed on the membrane had an electrical flex immersed in water and the earthing rod connection was unused.

8. Health and Safety – Carry out internal investigation and pass on findings to all site staff and EAW for information. Furthermore carry out a review of electrical safety when using welding equipment and generators on site.
